# TEMPORARY IMMERSION AND DUST TEST REPORT

Company : GradConn Ltd.  
 Address : No. 139 Wuhan Rd., Longtan Township, Taoyuan County, Taiwan  
 Sample Name : Refer to see page 2  
 Date Received : OCT 14, 2015  
 Date Tested : OCT 14, 2015 ~ OCT 19, 2015

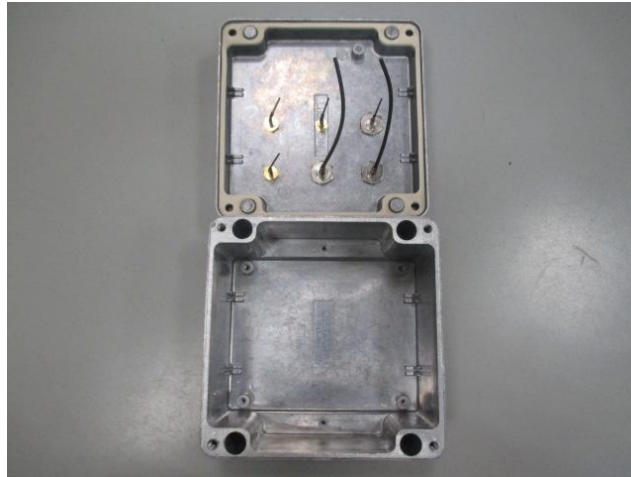
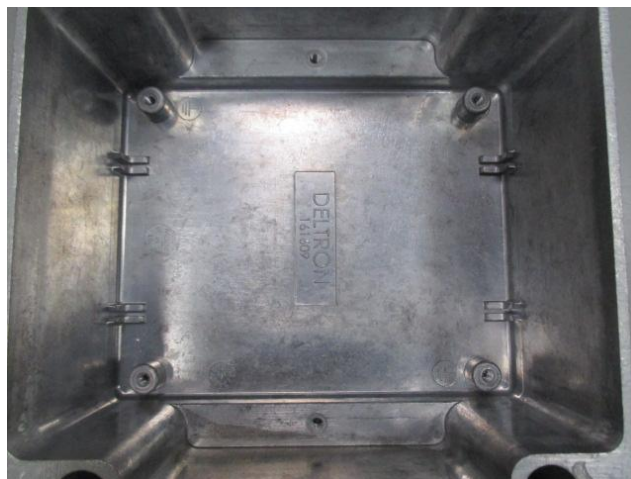
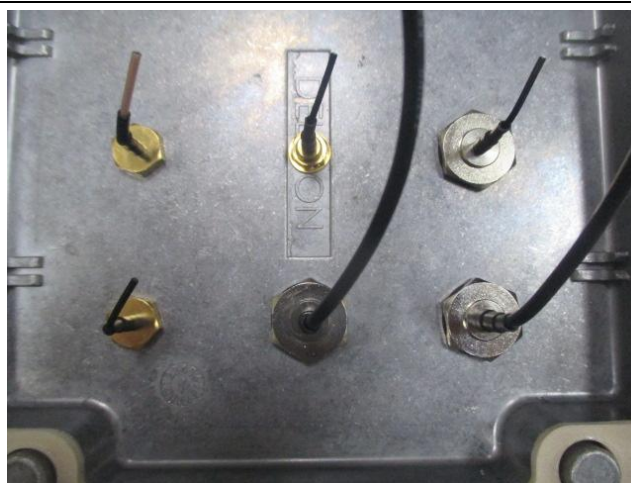
**Attachment 3 : Photo of unit after temporary immersion test**

After testing, visual inspection showed no water permeated into unit.

**No water permeated into unit**

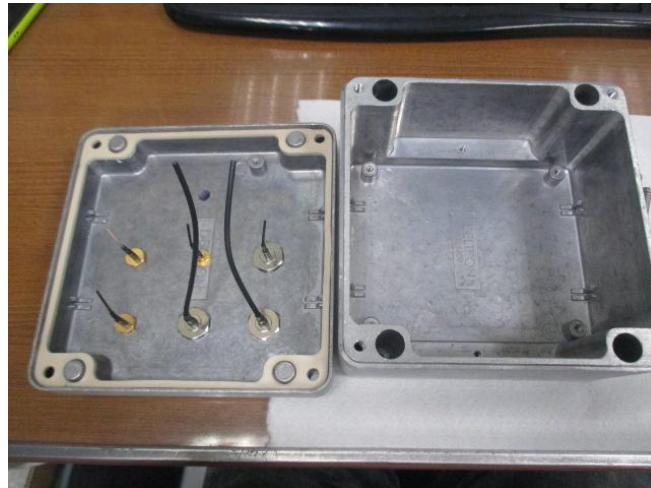
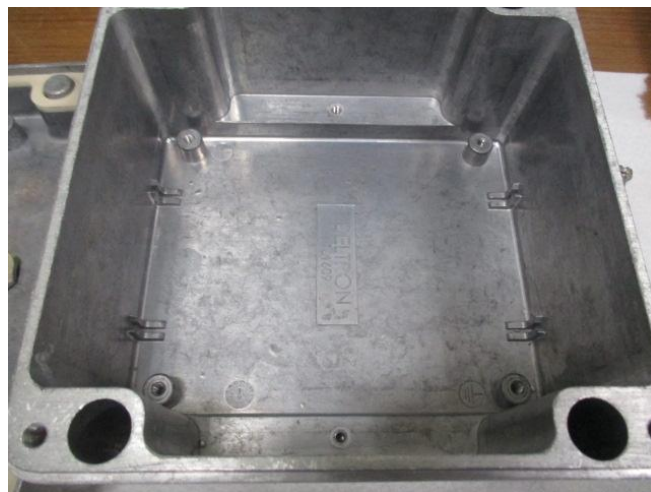
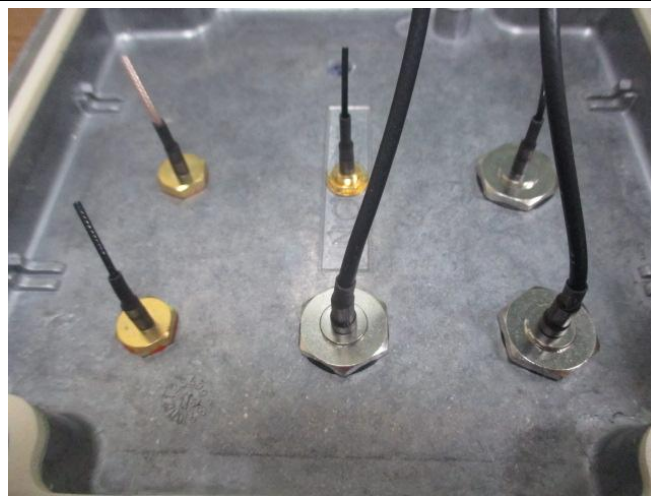
**Attachment 4 : Photo of unit after dust test**

After testing, visual inspection showed no dust particle permeated into unit.

**No dust particle permeated into unit**
