Test Report

Report No. A2200397792101001c

Sample Name SMA Jack Nautilus SS with EPDM O-Ring to I-Pex MHF

No.	Test Item
1	IP6X

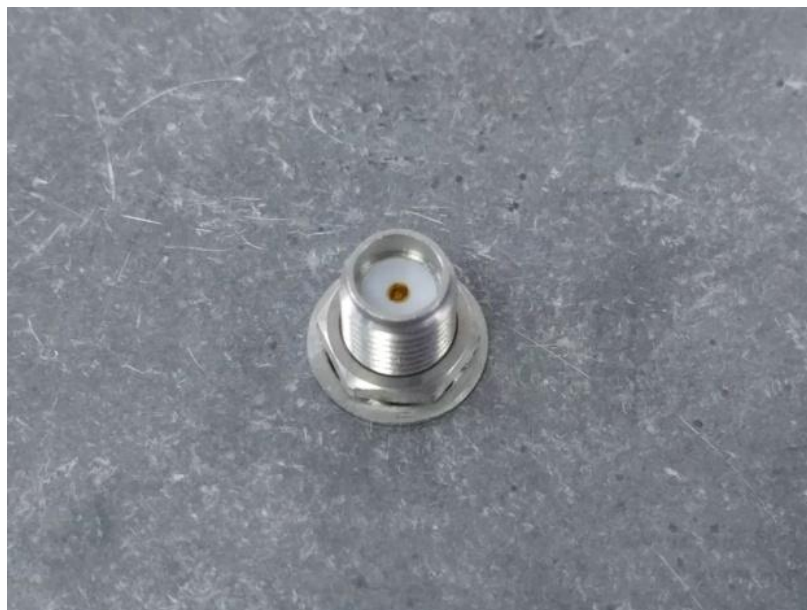
Sample No.	Sample Name	Type
A2200397792101001	SMA Jack Nautilus SS with EPDM O-Ring to I-Pex MHF	CAB412RF-0050-1-E

Sample Photo(s)

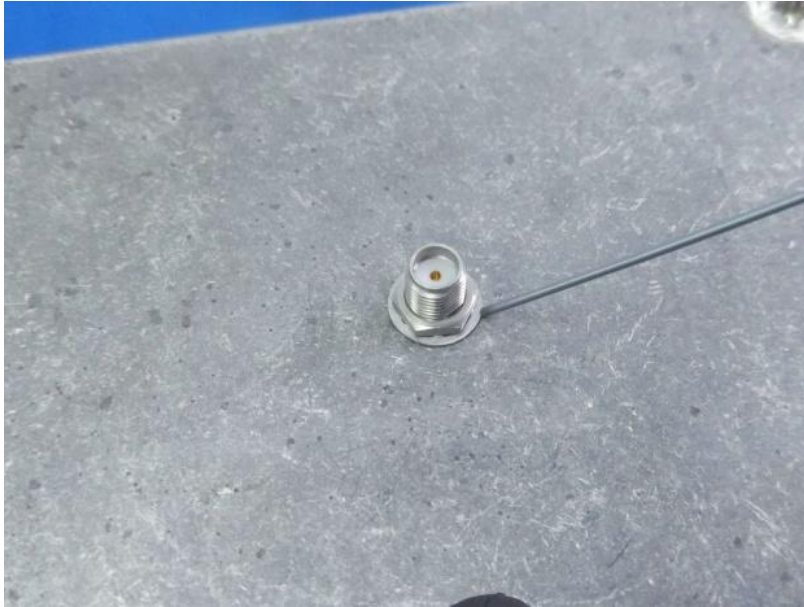
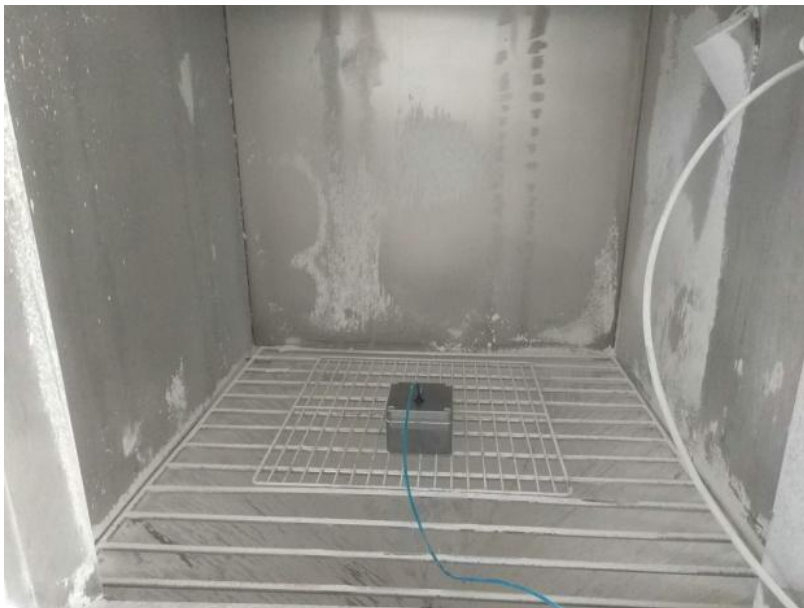
-b) Set the sample in the dust chamber, the pressure inside the enclosure is maintained below the surrounding atmospheric pressure by a vacuum pump (Less than 40 times of the shell volume per hour; the differential pressure between the containment and the atmosphere: $\leq 2\text{kPa}$);

Test Set-up Photo

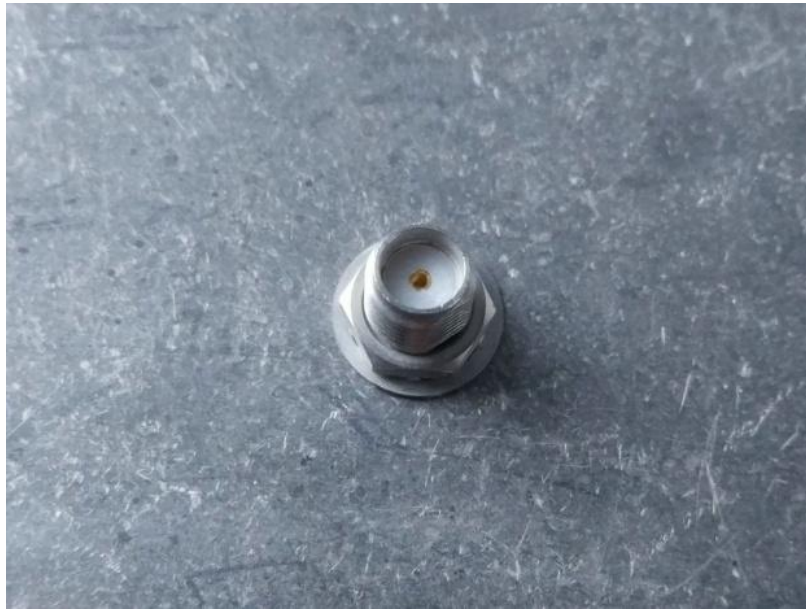
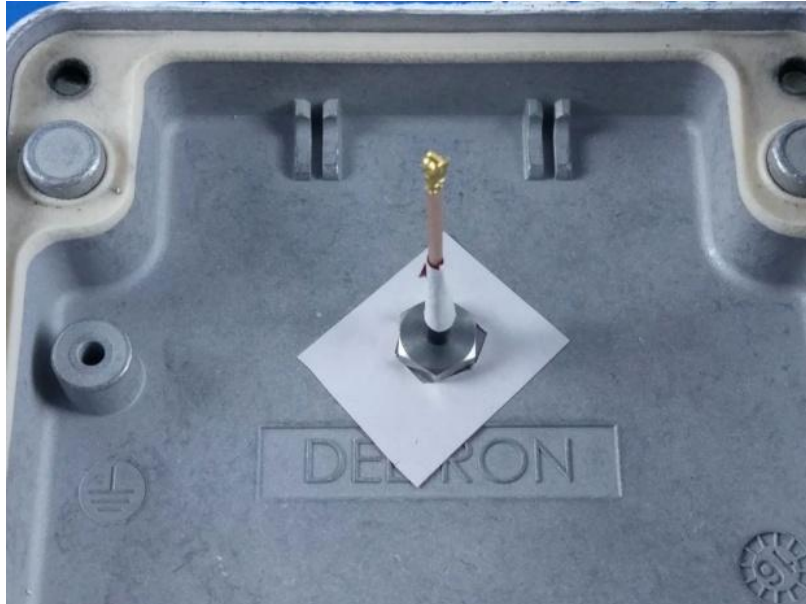
Sample No.	Result	Conclusion
A2200397792101001	Visual inspection, test probe cannot into the sample. No obvious dust was observed in the sample after test.	PASS

Sample Photo(s) after the test
