# TEMPORARY IMMERSION AND DUST TEST REPORT

Company : GradConn Ltd.  
 Address : No. 139 Wuhan Rd., Longtan Township, Taoyuan County, Taiwan  
 Sample Name : Refer to see page 2  
 Date Received : OCT 14, 2015  
 Date Tested : OCT 14, 2015 ~ OCT 19, 2015

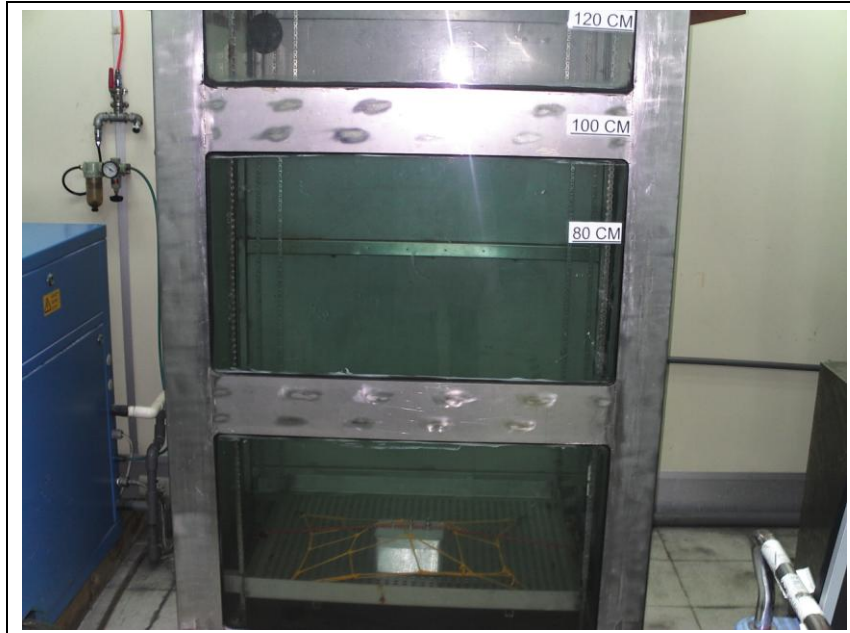
**Attachment 1 : Photo of temporary immersion test setup**

After testing, visual inspection showed no water permeated into unit.

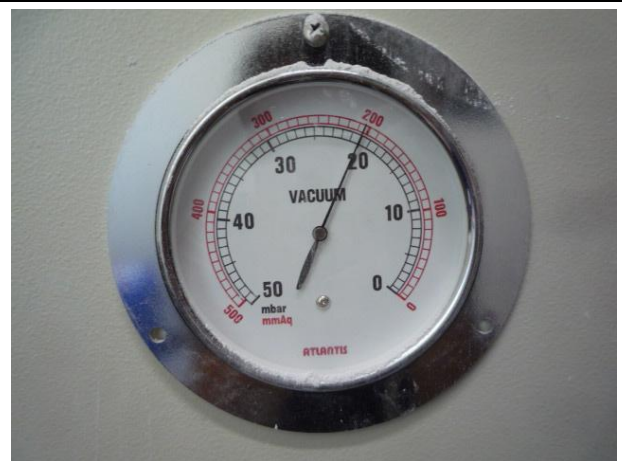
Depression level : 20 mbar
